**Evaluation of Corrosion Resistance of New and Upcoming Post-Tensioning  
Materials After Long-Term Exposure Testing**

**Thesis**

The University of Texas at Austin

**December 2010**

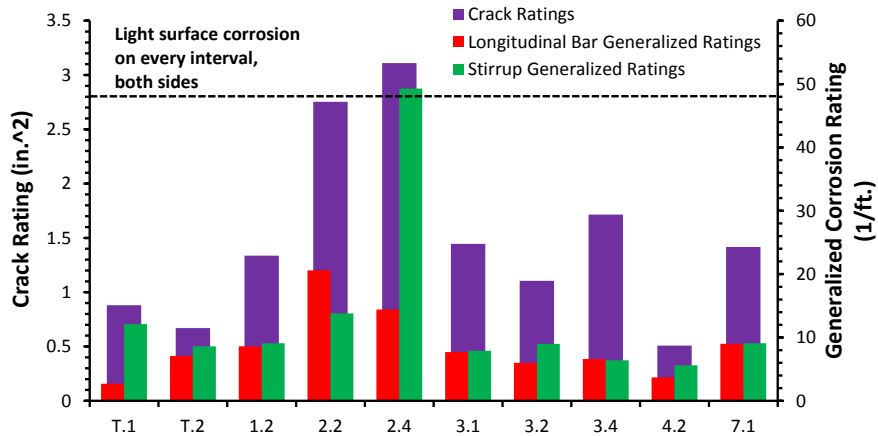
**Figure 6.2: Generalized Longitudinal Bar and Stirrup Corrosion Ratings and Crack Ratings**

Overall, the specimens' epoxy-coated reinforcing elements were in good condition. Corrosion damage was mild and limited to small areas of each bar or stirrup. In between these regions, the epoxy coating was completely intact. Discoloration and corrosion tended to occur at locations where damage to the epoxy coating was likely to have occurred, such as points where the bars had been tied or lifted with a crane. Pitting and area loss were extremely rare. Discoloration was the most common form of corrosion damage.

Generalized longitudinal bar and stirrup corrosion ratings are shown in Figure 6.2 and plotted with crack ratings for each specimen. In general, it appears that specimens with higher crack ratings also tend to have higher longitudinal bar and stirrup corrosion ratings. For most specimens, it was observed during autopsy that corrosion ratings were highest for the regions of the bars and stirrups located directly underneath each specimen's surface cracks. Figure 6.2 builds on this finding by linking the extent of epoxy-coated bar corrosion to crack rating.

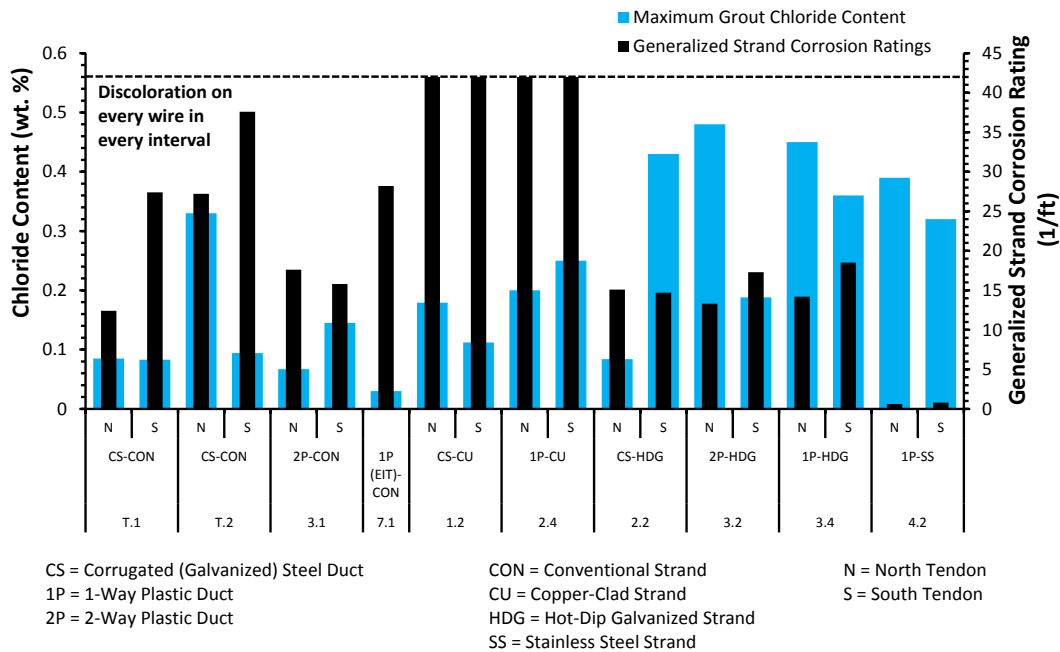
**Figure 6.3: Generalized Strand Corrosion Ratings and Maximum Tendon Chloride Content, Organized by Strand Type**

Because the different strand types corroded in different ways, direct comparison among them is difficult. Generalized strand corrosion ratings are plotted with maximum chloride content for both tendons in each autopsy specimen in Figure 6.3. Note that the plots are organized by strand type.

For tendons with conventional strand, only Specimen 7.1 (electrically isolated tendon) had a maximum chloride content below the corrosion threshold. The north duct of Specimen T.2 had the highest strand corrosion rating but one of the lowest grout chloride concentrations. The south tendon of Specimen T.1, the north tendon of T.2, and the tendon in Specimen 7.1 all had similar generalized strand corrosion ratings. However, the maximum chloride content of these tendons varied dramatically, showing that corrosion rating is not dependent on chloride concentrations once the corrosion threshold has been exceeded.

The copper clad strands all took on a uniform black patina during their life. As a result, their generalized strand ratings were identical. However, all maximum chloride concentrations were above the corrosion threshold, varying from 0.11% to 0.25%. Therefore, corrosion of copper-clad strand was independent of chloride content above the corrosion threshold for copper-clad strand.

For the specimens with hot-dip galvanized strand, generalized corrosion ratings were relatively uniform. However, chloride concentrations ranged from 0.08% to 0.48%. Again, this suggests that corrosion of galvanized strand was independent of chloride concentration past the corrosion threshold.

Only one specimen with stainless steel strands was autopsied. Generalized strand corrosion ratings were very low in both tendons of Specimen 4.2, while maximum chloride concentrations were about ten times higher than the corrosion threshold. This shows that the stainless steel strands were extremely corrosion resistant.

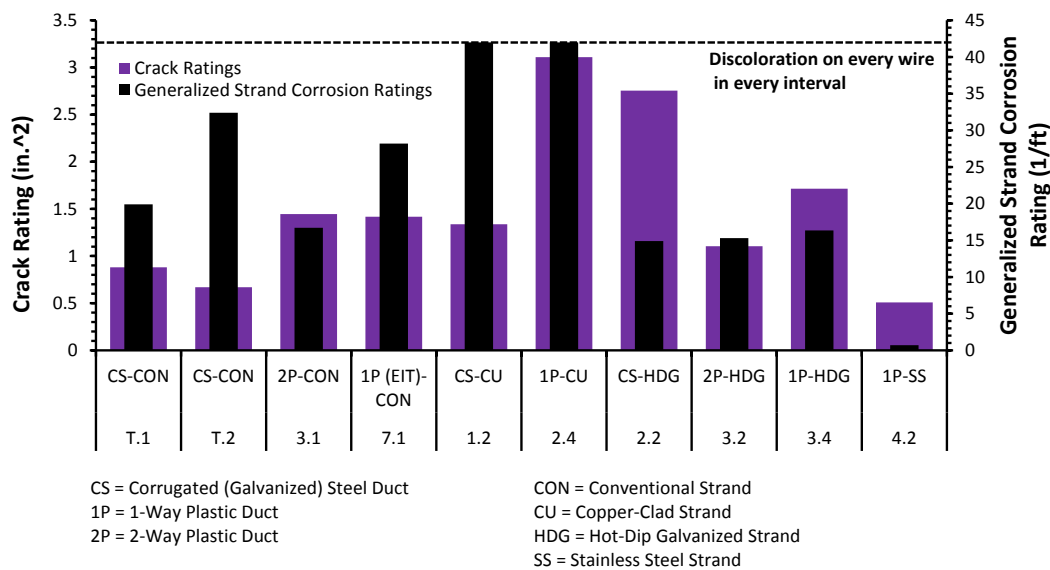
**Figure 6.4: Average Generalized Strand Corrosion Ratings and Crack Ratings, Organized by Strand Type**

Figure 6.4 shows generalized strand corrosion ratings plotted with crack ratings for each specimen. The corrosion ratings shown represent the average of the tendons in each specimen. For each individual strand type, there is no clear correlation between strand corrosion rating and crack rating. High crack ratings do not necessarily correspond to high corrosion ratings. If cracking is assumed to indicate the extent of chloride ingress, this data confirms that strand corrosion does not depend on chloride content above the corrosion threshold.

Overall, the stainless steel strands performed the best. Copper-clad strands also showed no corrosion. Hot-dip galvanized and conventional strands had spots of discoloration and corrosion but were substantially intact. Based on observed corrosion damage alone, stainless steel strand would be best suited to prolonging the service life of a structure.

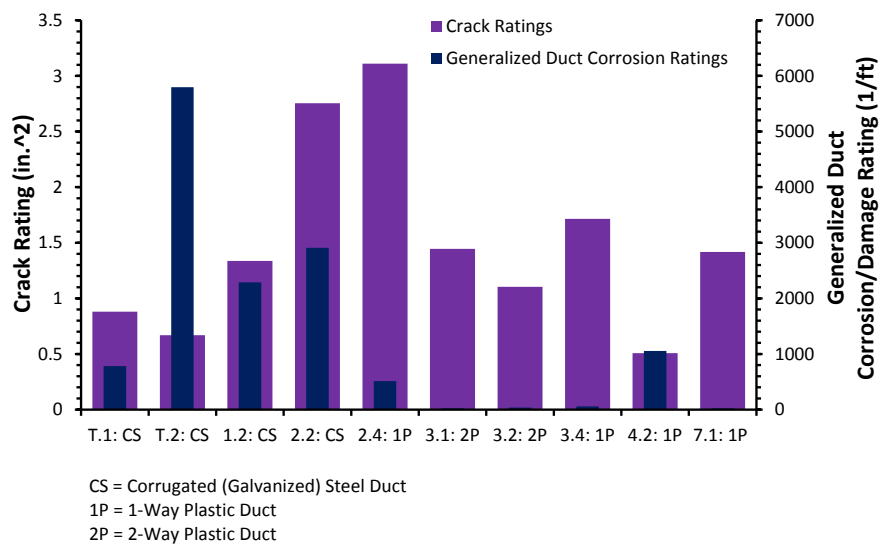
**Figure 6.5: Average Generalized Duct Corrosion/Damage Ratings and Crack Ratings**

The autopsy specimens contained galvanized steel duct or one of three types of plastic duct from two suppliers. Specimen 7.1, which was electrically isolated, contained the same type of one-way plastic duct as Specimens 3.4 and 4.2. In Figure 6.5, average generalized duct corrosion or damage ratings for each specimen are plotted with crack ratings.

Among the four specimens with galvanized steel ducts, corrosion ratings increased with crack ratings for Specimens T.1, 1.2, and 2.2. However, the highest duct corrosion ratings

occurred for Specimen T.2, which had the lowest crack rating. This suggests a correlation between crack rating and duct corrosion rating, but other factors must also influence the extent of corrosion. From the forensic analysis, it was clear that corrosion initiated in the galvanized steel ducts at locations corresponding to each specimen's transverse surface cracks. For Specimen T.2, cracking allowed duct corrosion to initiate at crack locations, then travel along the length of the large voids as chlorides continued to enter the tendons. Therefore, crack location and the presence of grout voids are just as important as crack rating in determining the extent of duct corrosion.

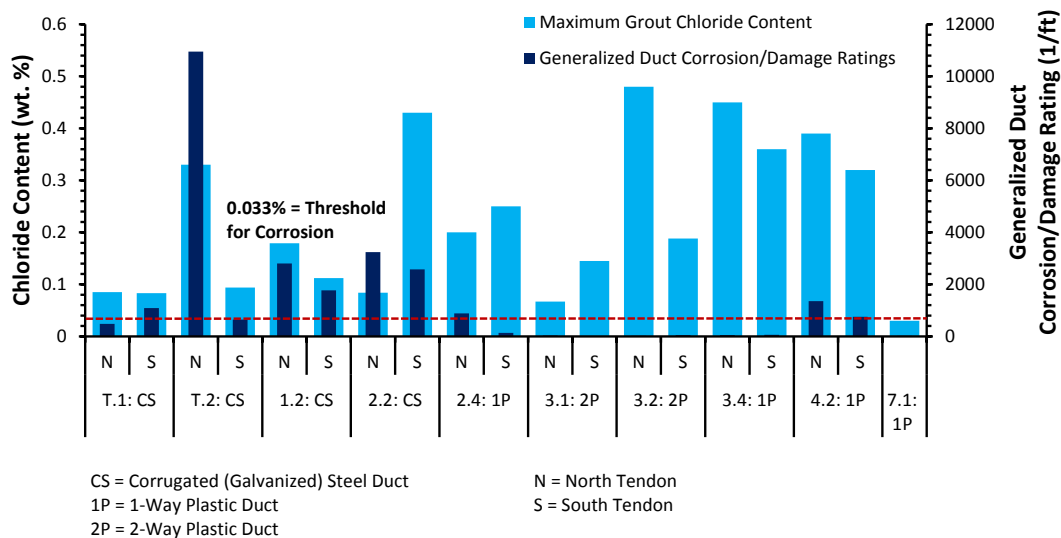
**Figure 6.6: Generalized Duct Corrosion/Damage Ratings and Maximum Grout Chloride Content**

Figure 6.6 shows generalized duct corrosion and damage ratings plotted with maximum chloride content in each tendon. For the steel ducts, chloride content seemed to increase in each tendon along with the generalized corrosion rating in the surrounding duct. However, the highest overall chloride contents occurred in tendons with plastic ducts. This is a puzzling result, given the extensive area loss in the steel ducts. However, it confirms the presence of leaks in the couplers of the north plastic ducts and the grout vents of the south plastic ducts, as observed during the autopsy process. Plastic duct damage ratings showed no correlation to the grout chloride content.

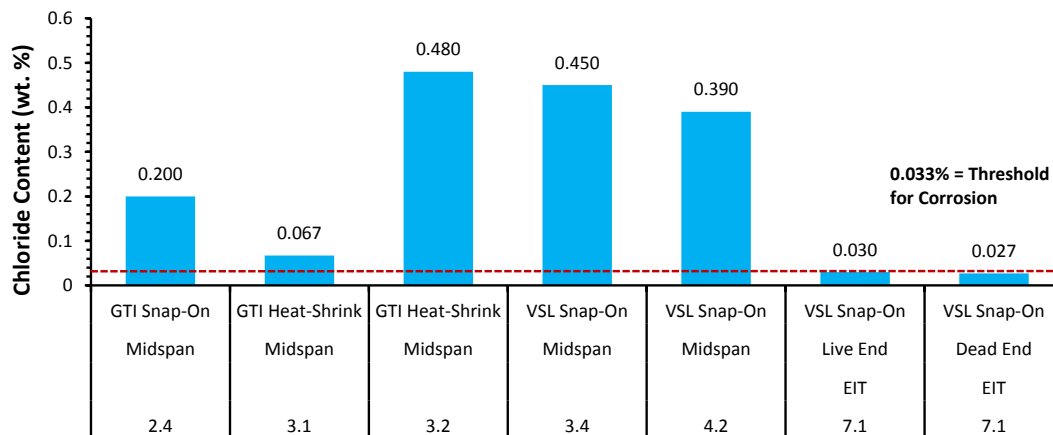
**Figure 6.7: Grout Chloride Contents at Coupler Locations**

The specimens with galvanized steel ducts did not contain couplers. In each specimen with plastic ducts, the two halves of the north duct were connected with one of three couplers: GTI slip-on, GTI snap-on, or VSL snap-on. For each specimen, Figure 6.7 shows the chloride content within the tendon grout at the location of each coupler.

The highest grout chloride concentration was found inside the GTI heat shrink coupler within Specimen 3.2. The lowest concentrations were found in both VSL snap-on couplers inside Specimen 7.1, although these couplers had the benefit of being covered with an additional plastic sheath. Both chloride concentrations in Specimen 7.1 were below the corrosion threshold. The presence of chlorides within the couplers confirms that breaches had occurred, as observed during autopsies. For each coupler which was installed in more than one specimen, chloride concentrations vary significantly. This suggests that the integrity of the couplers depends more on workmanship during construction than on coupler type and manufacturer. The inexperience of the project team at construction time may have resulted in couplers which were not properly installed and which allowed chloride ingress during exposure.

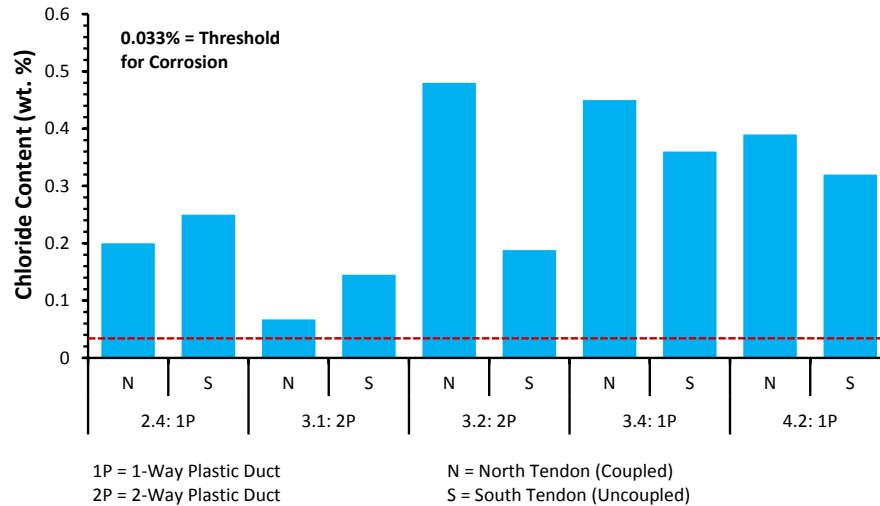
**Figure 6.8: Midspan Grout Chloride Contents for Specimens with Two Plastic Ducts**

For all specimens with one coupled and one uncoupled plastic duct, grout chloride concentrations at midspan are plotted in Figure 6.8. From this figure, it is clear that chloride levels at midspan were well above the corrosion threshold in both tendons of each specimen. While chloride levels were generally higher in the north tendons, concentrations were of similar

magnitude in the corresponding south tendons. This is most clear for Specimens 2.4, 3.4, and 4.2, for which both chloride concentrations were nearly equal. This trend confirms that the grout vents at midspan of the south ducts were indeed breached by chlorides during the exposure period.

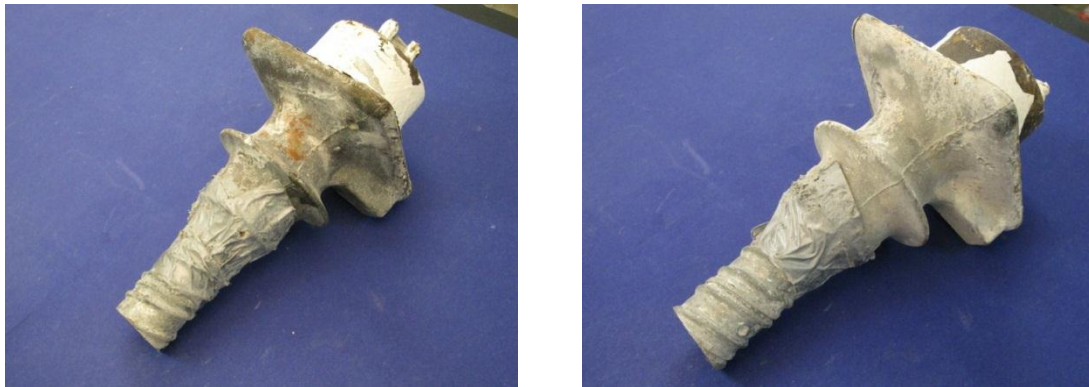
***Figure 6.9: Underside View of Anchorage with Non-Galvanized Bearing Plate (Left) and Galvanized Bearing Plate (Right)***

Of the autopsy specimens, only T.2 had been constructed with galvanized bearing plates. Corrosion occurred at similar locations on the galvanized and non-galvanized bearing plates. Most corrosion was found on the underside of the bearing plates and on their end surfaces. The galvanized bearing plates were generally less corroded, and the corrosion which was found had occurred on the zinc, not on the steel beneath (see Figure 6.9).

Specimens T.1 and T.2 were both constructed with steel ducts and conventional steel strand, so these specimens can be used to compare the effects of bearing plate type on other elements within the specimens. Less corrosion was found on the bearing plate splice regions of the ducts in Specimen T.2 than Specimen T.1. This suggests that the galvanized bearing plates may have acted as a sacrificial anode and reduced corrosion in the galvanized ducts connected to them. Conversely, slightly more corrosion was found on the anchorage region strands in Specimen T.2 than in T.1. This may have been galvanic corrosion caused by the difference in potentials between the zinc bearing plates and the plain steel strands.

The galvanized bearing plates in Specimen T.2 performed better than the non-galvanized plates in Specimen T.1. However, the effect of the galvanizing zinc on the corrosion of other steel elements is not fully understood and should be carefully weighed before opting for galvanized bearing plates in a post-tensioned structure. In addition, the non-galvanized bearing plates on all other autopsy specimens showed corrosion but remained structurally intact after four years of exposure. This casts doubt on the need for galvanized components in the first place.

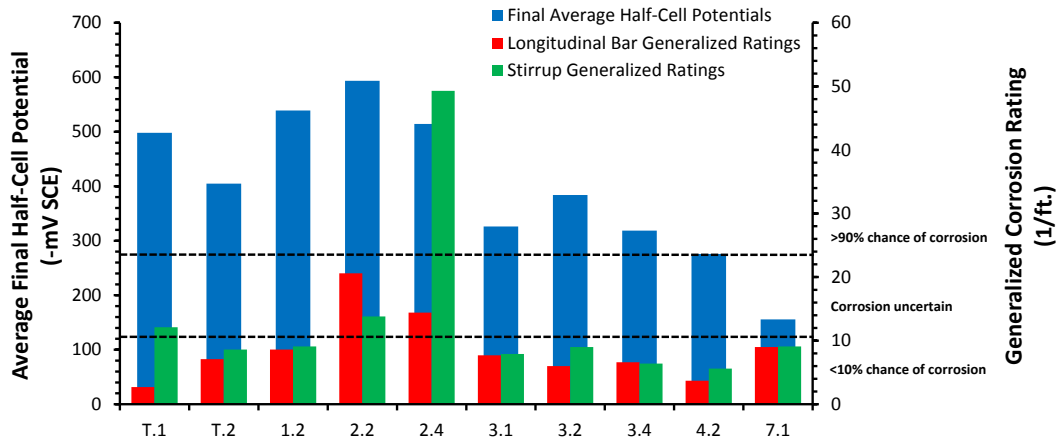
**Figure 6.10: Average Final Half-Cell Potentials and Generalized Longitudinal Bar and Stirrup Corrosion Ratings**

Average final half-cell potentials for each specimen are shown in Figure 6.10 with generalized longitudinal bar and stirrup corrosion ratings. All specimens except for 7.1 ended the test period with an average half-cell potential within the 90% chance of corrosion region, indicating that corrosion is very likely to be present<sup>14</sup>. Specimen 7.1 ended the test period in the uncertain corrosion category. Corrosion was present to some extent on the bars and stirrups in all specimens. In the sense of predicting the presence of corrosion, the final half-cell potential method was accurate. However, the half-cell potentials did not correlate well to the magnitude of the stirrup and longitudinal bar generalized corrosion ratings. Thus, the half-cell method did not accurately predict the relative severity of corrosion for the mild steel components in the autopsy specimens.

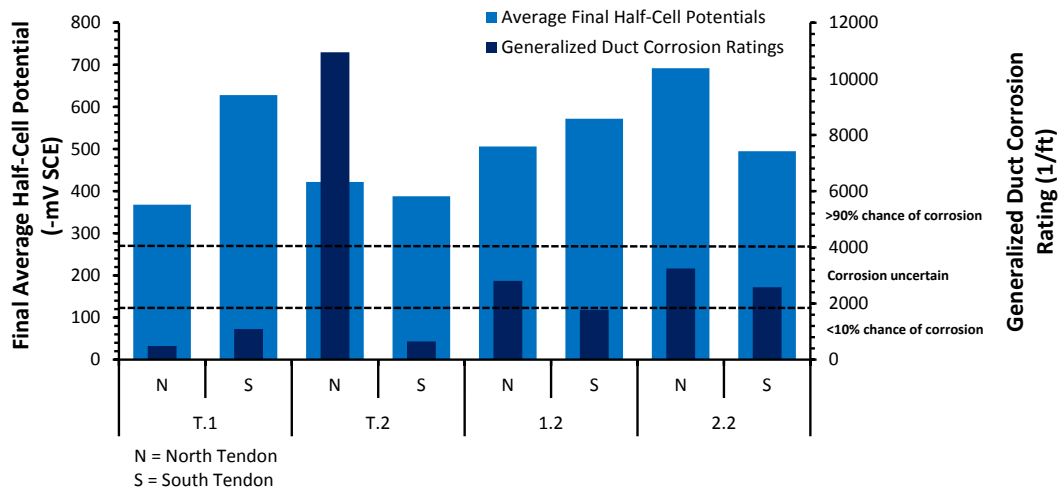
**Figure 6.11: Average Final Half-Cell Potentials and Generalized Duct Corrosion Ratings for Specimens with Galvanized Steel Duct**

Average final half-cell potentials for the north and south tendon in every specimen are shown in Figure 6.11 plotted with generalized duct corrosion ratings. Only the specimens with galvanized steel ducts were considered because the half-cell method would be unable to predict damage to the plastic ducts. For these four specimens, final average half-cell readings were all in the greater than 90% chance of corrosion range. This might indicate that half-cell readings predicted corrosion in those specimens. However, almost all of the specimens with plastic ducts also had readings within the 90% probability range, as shown in Figure 6.10. It is likely that the presence of duct corrosion made the half-cell readings more negative, but they were already very negative due to rebar corrosion.

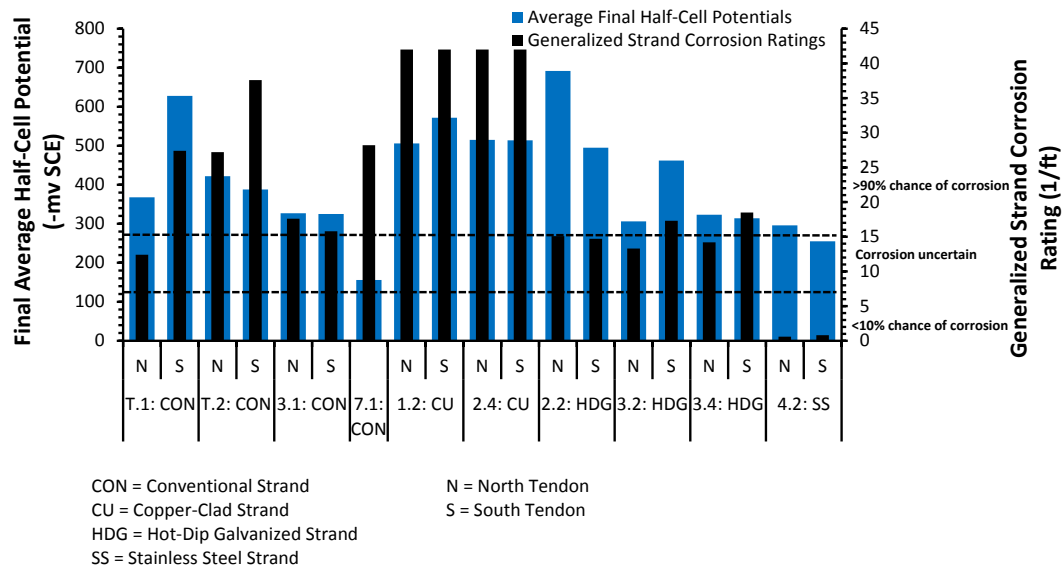
**Figure 6.12: Average Final Half-Cell Potentials and Generalized Strand Corrosion Ratings**

Figure 6.12 shows average final half-cell potentials plotted with generalized strand corrosion ratings for north and south tendons of each Specimen, grouped by strand type. Final half-cell potentials for all seven tendons with conventional strand indicated that corrosion was uncertain or more than 90% likely. Because all conventional strands had some corrosion, the half-cell method was accurate in this regard. However, no relationship can be seen between the final half-cell potential and generalized corrosion rating.

The copper-clad strands all had identical strand corrosion ratings. Half-cell potential readings for the tendons in Specimens 1.2 and 2.4 were similar, and all four were within the 90% chance of corrosion range. Because the black patina on the strands in every specimen was so uniform, it is unknown how half-cell potentials correlate to copper-clad strand corrosion.

The three specimens with hot-dip galvanized strands all showed similar generalized corrosion ratings. Final average half-cell potentials were all above the 90% threshold and generally decreased from Specimen 2.2 to 3.2 to 3.4. In this case, a slight correlation can be seen between half-cell potential and strand corrosion rating.

Almost no corrosion was found on the stainless steel strands in Specimen 4.2. However, the final average half-cell potentials for the two tendons in that specimen indicated that corrosion was uncertain or more than 90% likely. The half-cell method was not accurate for stainless steel strands.

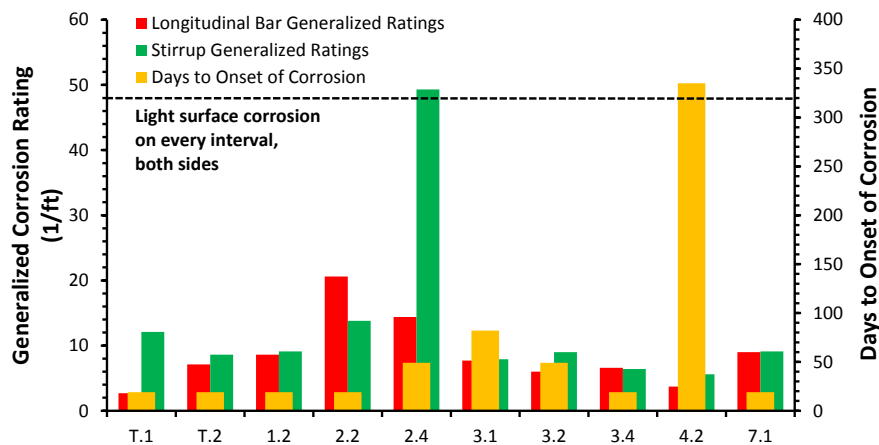
**Figure 6.13: Longitudinal Bar and Stirrup Generalized Corrosion Ratings and Days to Onset of Corrosion**

of corrosion for each specimen is shown in Figure 6.13 along with generalized longitudinal bar and stirrup corrosion ratings.

There was not much variation in the time to onset of corrosion among most autopsy specimens, which makes comparison difficult. Times to corrosion onset tended to be lower for specimens with higher bar and stirrup corrosion ratings, although this trend is not universal. The longest time to corrosion onset was observed in Specimen 4.2, which also had the least amount of corrosion on its bars and stirrups.

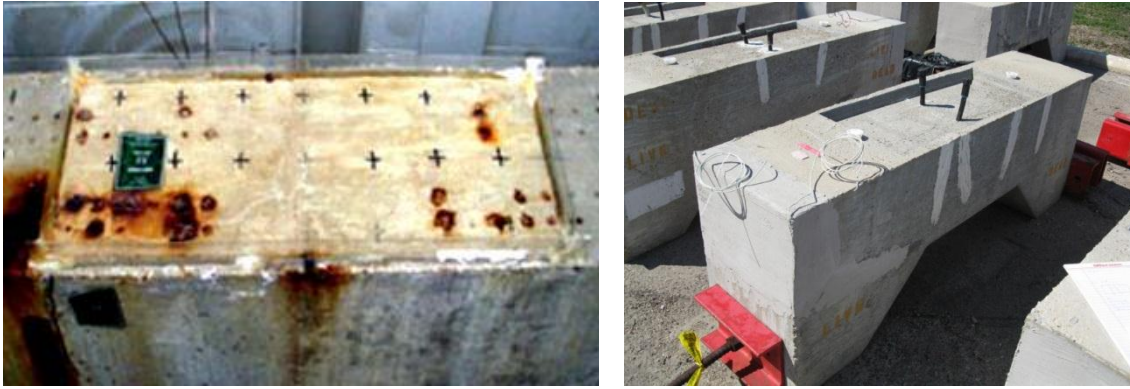
*Figure 6.18: Typical Specimen from Project 0-1405<sup>8</sup> (Left) and Project 0-4562 (Right)*

The 0-1405 autopsy specimens were poor in appearance. Most specimens had moderate to severe staining on their top surface. Expansive stresses due to internal corrosion resulted in extensive surface cracking in addition to the pre-existing flexural cracks on some specimens. The large cracks provided easy ingress for chlorides from the top surface saltwater pond, and corrosion easily spread to regions of the specimens where no flexural cracks had been present.

The Project 0-4562 specimens were much better in appearance. Limited staining was observed on a few specimens, although some efflorescence was present on the top and end face surface cracks of several others. Additional cracks formed on some specimens after live load application, but there is no evidence to suggest that these cracks were the result of expansive stresses due to corrosion products within the specimens. The external appearance of typical specimens from both projects is shown in Figure 6.18.

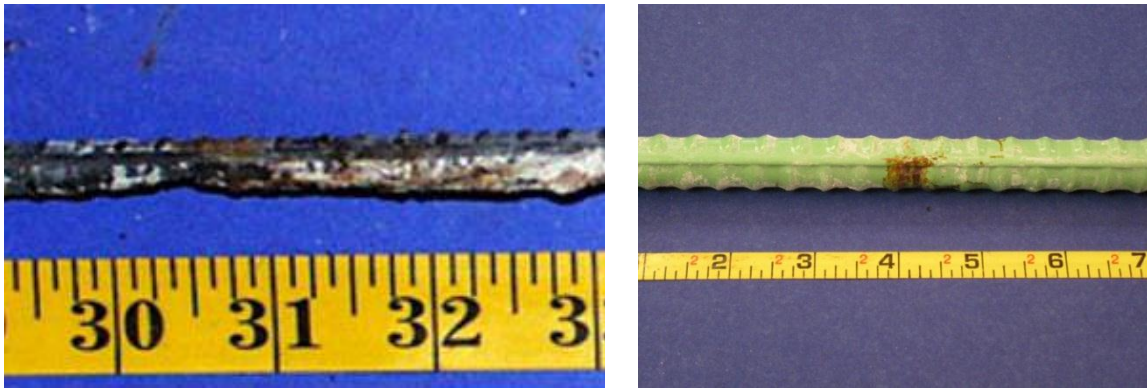
*Figure 6.19: Typical Longitudinal Bar from Project 0-1405<sup>8</sup> (Left) and Project 0-4562 (Right)*

Uncoated rebar was used to form the longitudinal bars and stirrups of each 0-1405 specimen. These bars were found to have serious corrosion over most of the autopsy region. This corrosion resulted in substantial area loss, especially in the partially prestressed specimens. Crack width was observed to have a direct effect on the corrosion of reinforcement.

Project 0-4562 specimens made use of epoxy-coated rebar. Some discoloration and corrosion were present at locations where the coating was most likely to have been disturbed, such as bar curves and lifting points. Pitting was even found on occasion. However, most of the bars' and stirrups' epoxy coating remained intact, preventing widespread corrosion to those components. This indicates substantial value in the use of epoxy-coated reinforcement in aggressive exposures. A typical longitudinal bar from both projects is shown in Figure 6.19.

The epoxy-coated mild steel reinforcement showed minimal corrosion which mostly occurred at the points where it had been handled or disturbed in some way. It is recommended that epoxy-coated rebar fulfill the applicable ASTM standard. The rebar must also be handled with care to avoid damaging the coating. Any defects which arise during handling or construction should be patched with the appropriate repair compound prior to casting. In many instances, coating damage was caused by the coated rebar ties which were used to construct the reinforcement cages of the autopsy specimens. It is therefore recommended that epoxy-coated rebar be tied with plastic ties to minimize coating damage.
